Mobile Intel[®] Celeron[®] Processor at 466 MHz, 433 MHz, 400 MHz, 366 MHz, 333 MHz, 300 MHz, and 266 MHz Specification Update

Release Date: October 2002

Order Number: 244444-037

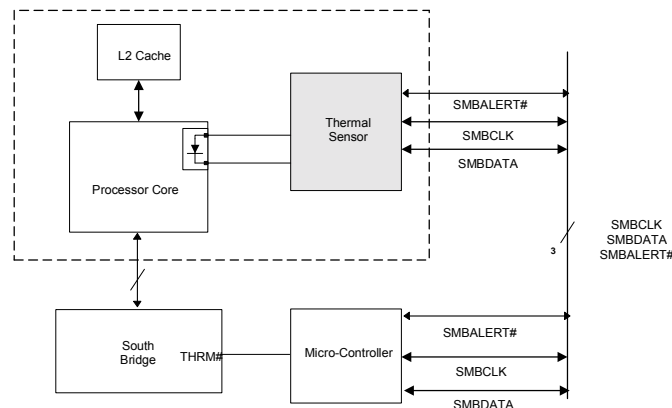
Figure 1. An Example of Microcontroller Driven Thermal Management

H29. Thermal Sensor May Assert SMBALERT# Incorrectly

Problem: The Intel Celeron Processor Mobile Module has a thermal sensor that monitors the processor core's temperature. Please note that desktop systems could have a similar thermal device. The thermal sensor asserts SMBALERT# if the processor temperature exceeds the temperature limits set in the Alarm Threshold Registers (T_{HIGH}, T_{LOW}). It also sets the corresponding Status Register bits to identify the cause of the interrupt. Figure 1 gives one example of the how the SMBALERT# signal could be used in a system.

Implication: There is no system impact from this erratum if temperature polling is used for processor thermal management. If the SMABLER# interrupt is employed to manage processor thermal sensing, then servicing the false interrupt may result in premature system action depending on the software and hardware implementations used. The rate of the false interrupts is less than the auto-convert rate of the thermal sensor.

Workaround: Three different (mutually exclusive) workarounds are possible:

1. Before servicing an interrupt from the thermal sensor, read and compare the processor thermal reading with the threshold limits (T_{HIGH} or T_{LOW}). Figures 2 and 3 provide basic flowcharts for the implementation of this workaround in an interrupt driven system.
2. If the firmware implemented polls the Status Register only, then before taking any action, re-read the temperature register and do a comparison with the alarm threshold limits (T_{HIGH} or T_{LOW}) to determine if the value is actually still within the temperature window.
3. Use a temperature polling scheme to monitor the processor temperature.
